LAKE FOREST PARK LAKEFRONT IMPROVEMENTS CITY OF LAKE FOREST PARK

EXISTING CONDITIONS

Lake Forest Park – Lakefront Park & Lyon Creek Waterfront Preserve Timber Pier Condition Assessment

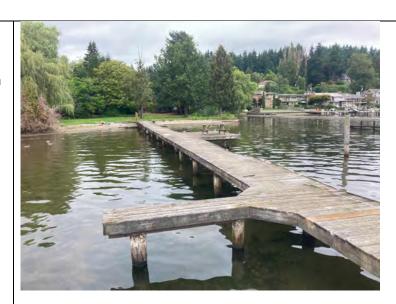
Lakefront Image 1.

Overview of timber pier taken from far waterside end

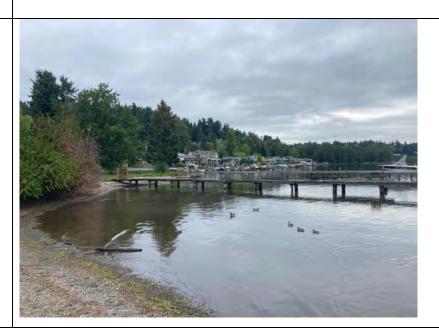
Lakefront Image 2.

Profile view of timber pier taken from Lyon Creek Park

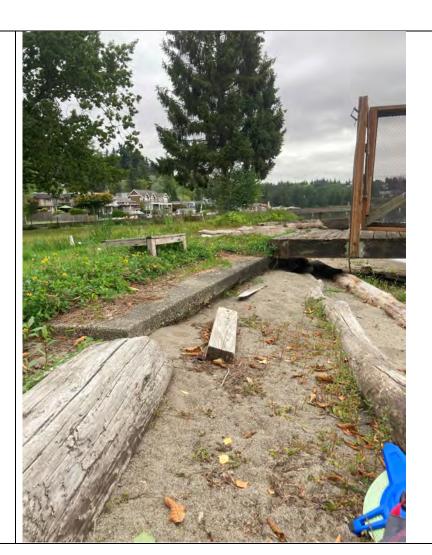
Lakefront Image 3.

A concrete slab serves as the primary structural support for the timber pier on the shoreside landing area. The slab ranges between Poor to Serious condition in its current state. Undermining of sediment material exists on the toe side of the slab. It also appears that significant weathering and loss of section is present on the toe side of the slab where it has been exposed to waves and debris impact. Finally significant spalling is noticeable on exposed edges. (See Photo Log)

Pier Shoreside landing area slab

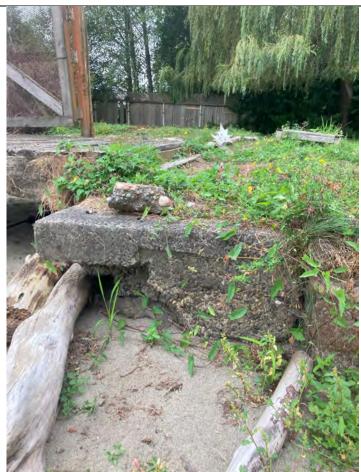
Lakefront Image 4.

- Pier Shoreside landing area slab (section loss, spalling and undermining occurring at exposed areas)

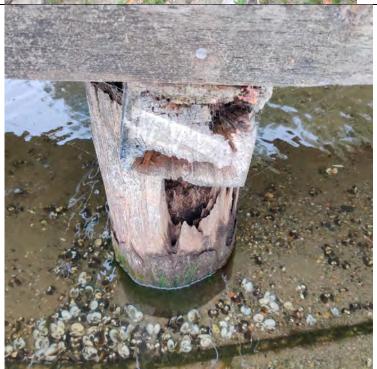
Lakefront Image 5.

Severe section loss rotting on pier pile and cap beam

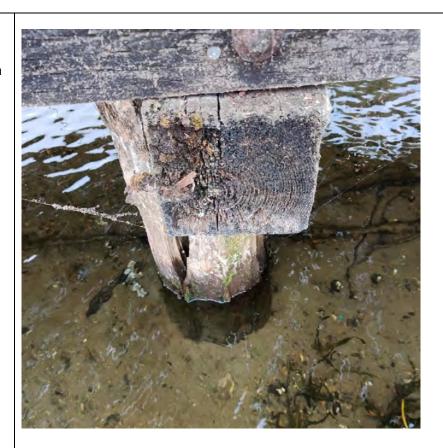
Lakefront Image 6.

Severe rotting on pier pile cap and splitting timber pile

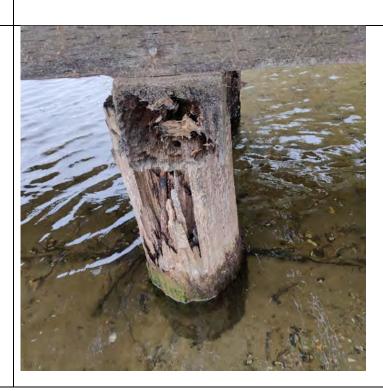
Lakefront Image 7.

Pile and Pile Cap in serious/critical Condition (50% section loss observed)

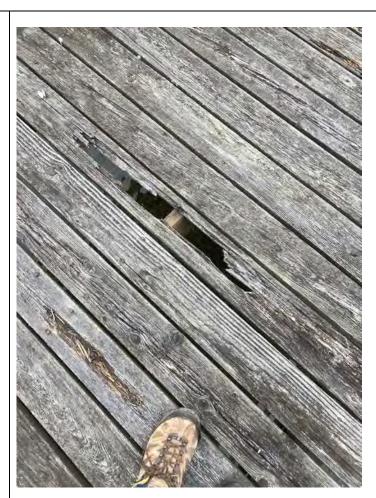
Lakefront Image 8.

Timber Decking in critical Condition, significant rot and holes observed.

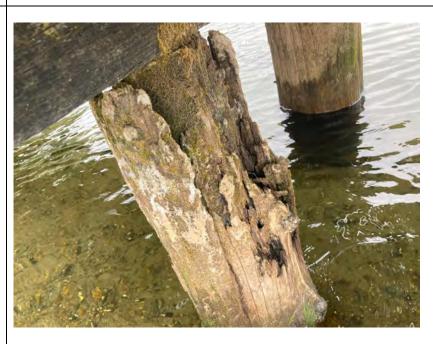
Lakefront Image 9.

Pile in Serious
 Condition, (loss of section/rot observed)

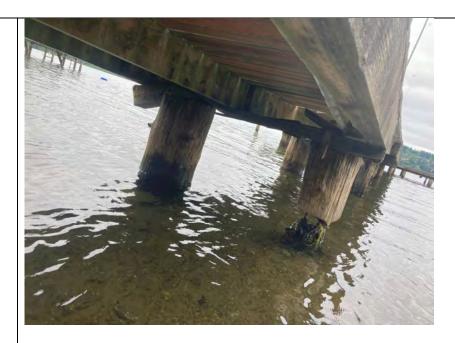
Lakefront Image 10.

Pile in Critical Condition,

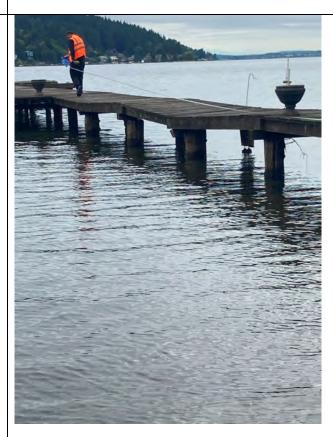
Lakefront Image 11.

Pier profile view, sagging observed between bents

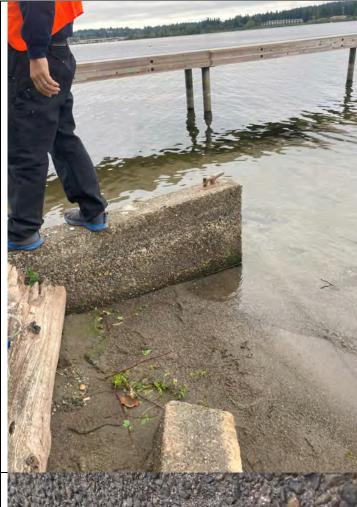
Lakefront Image 12.

A concrete bulkhead exists on the northern edge of the parcel which is aligned perpendicular to the shoreline along the property line. The Bulkhead is Poor Condition with Significant spalling present on exposed sections of wall. (See Photo Log)

Bulkhead/Wingw all on North property line

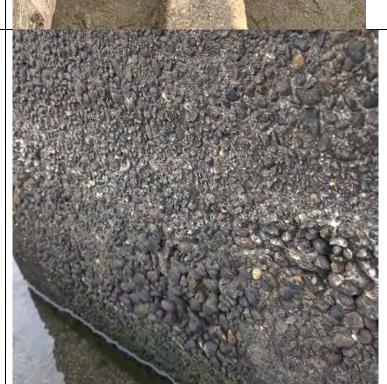
Lakefront Image 13.

Closeup view of Bulkhead concrete spalling

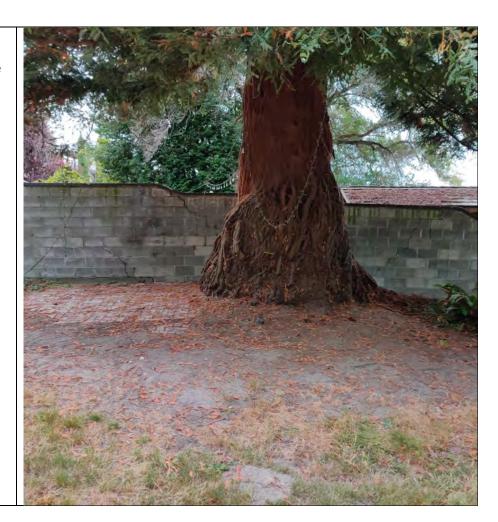
Lakefront Image 14.

An upland concrete barrier wall exists on the northern edge of the parcel along the property line. The barrier wall is Fair condition with some cracking observed. (See Photo Log)

Upland Concrete Barrier Wall (some cracking observed)

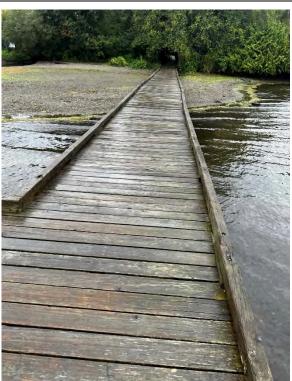
Lyon Creek Image 1.

Overview of timber pier taken from far waterside end

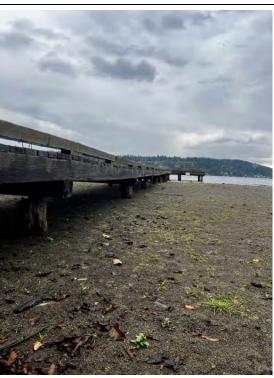
Lyon Creek Image 2.

Profile view of timber pier taken from Lyon Creek
 Park Shoreline (noticeable sagging observed)

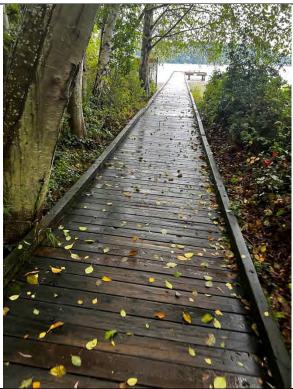
Lyon Creek Image 3.

Pier Shoreside landing area

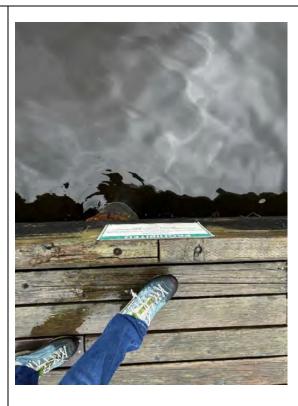
Lyon Creek Image 5.

Severe rotting on pier pile cap and timber pile

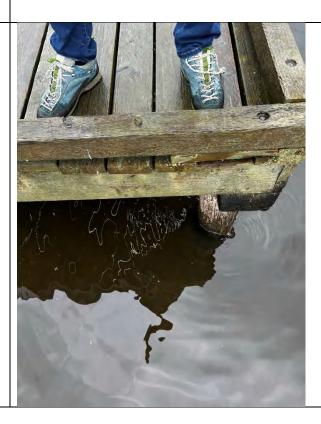
Lyon Creek Image 6.

Pile and Pile Cap in serious/critical Condition (50% section loss observed)

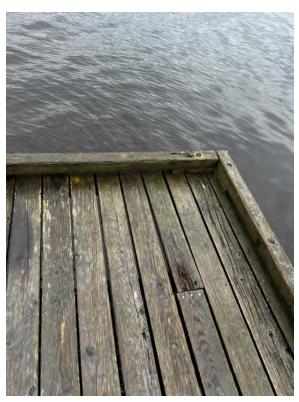
Lyon Creek Image 7.

- Timber Decking in Moderate to Poor Condition.

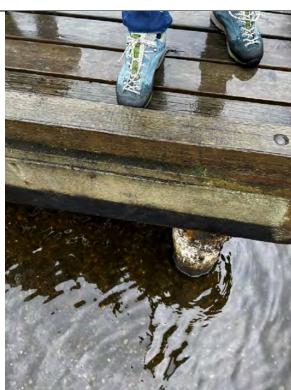
Lyon Creek Image 8.

- Pile in Serious Condition

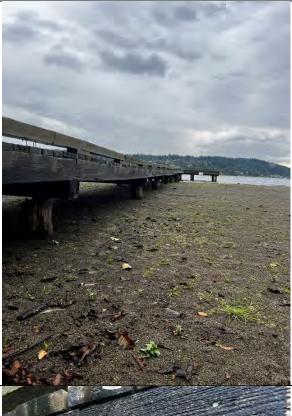
Lyon Creek Image 9.

Pier profile view, sagging observed between bents, rotting observed on pier pile cap and timber piles

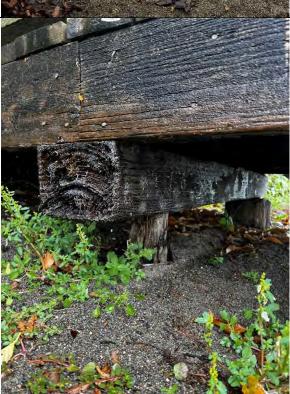
Lyon Creek Image 10. - rotting on pier pile cap and timber pile

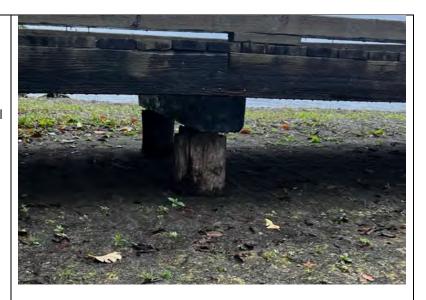
Lyon Creek Image 11.

- Piles in serious condition, section loss observed near cap connection (only drift pins/steel rods remain intact)
