LAKE FOREST PARK LAKEFRONT IMPROVEMENTS CITY OF LAKE FOREST PARK

EXISTING CONDITIONS

Lake Forest Park – Lakefront Park & Lyon Creek Waterfront Preserve Timber Pier Condition Assessment

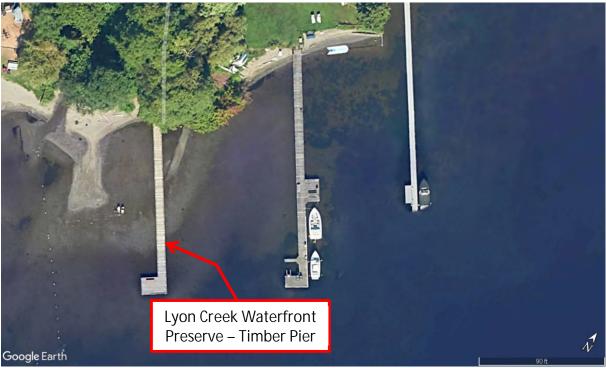
Figure 3 Aerial view of the Lyon Creek Park timber pier

Steve Robert, P.E. and Drew McDonald, P.E. were on site on September 25, 2023. The primary focus of the assessment was to visually inspect the key structural components of the pier which includes the pile supports, pile caps, pier stingers and decking. Overall, most of the timber piles were identified to have section loss and splits. Pile caps have significant rotting and section loss. Timber decking ranged between Poor to Satisfactory condition and looked to have been replaced in last 10 – 20 years. Timber stingers have noticeable marine growth and rot present. Notable sagging between bents was also observed. Inspection photos are shown in Appendix A, Photo Log.

Generally, both timber pier structures are in serious condition with the current condition of the structure deemed to be unsafe for public use. Full replacement and pier closure is recommended.

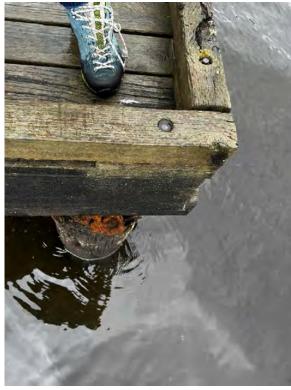
Lyon Creek Image 5.

Severe rotting on pier pile cap and timber pile

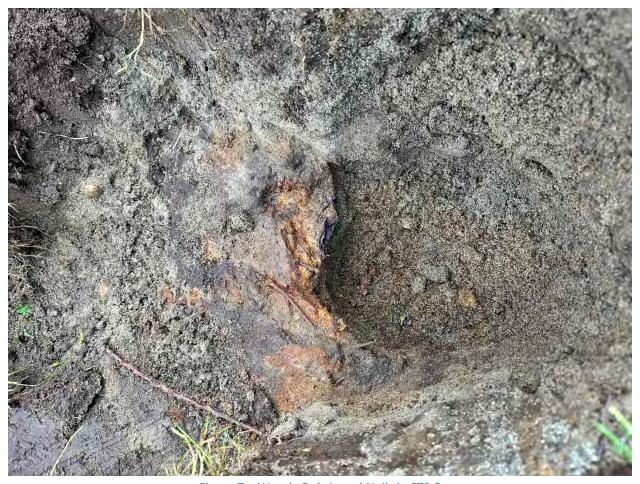
Figure 7. Woody Debris and Nails in STP 3

ASM completed the excavation of 12 STPs throughout the property. During STP excavations the archaeologists noted a consistent soil profile made up of 3 distinct layers (Figure 5). The first layer consisted of dark brown silty sand with very few rounded gravels; this layer is typical for a topsoil. Beneath this, a layer consisting of grayish brown sand with rounded to subrounded gravels overlaying a layer composed of grey sand with rounded to subrounded gravels. Modern plastic refuse, woody debris and nails were often found in this layer. The lower layer of each STP consisted of a bluish gray sand. Water filled up the bottom of most STPs, limiting the depth of the excavations. Several of the STP excavations were limited by roots and compaction. These STPs were located near some of the houses and were on or near extremely compact gravel driveways. STP 3 contained a large decaying piece of wood containing multiple rusted nails (Figure 6).

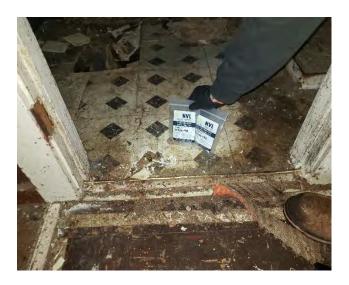
Photo #5: Samples 11720-39 & 40: 9"x9" Brown VFT on black mastic (on wood.) (9% Chrysotile)

Location: Building 9 Main Floor

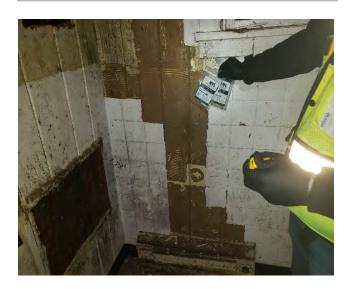
Photo #6: Samples 11720-44 & 45: 2"x2" Olive ceramic tile on yellow mastic on black mastic and 4"x3" white ceramic tile with yellow mastic (on wood.) (2% Chrysotile)

Location: Building 9 Shower Area
